Observations from Rhode Island salt marshes at risk to SLR. Indicators, metrics, measurements.

USFWS, Hurricane Sandy Resiliency
Coordinator.

Rhode Island Complex Coastal Restoration

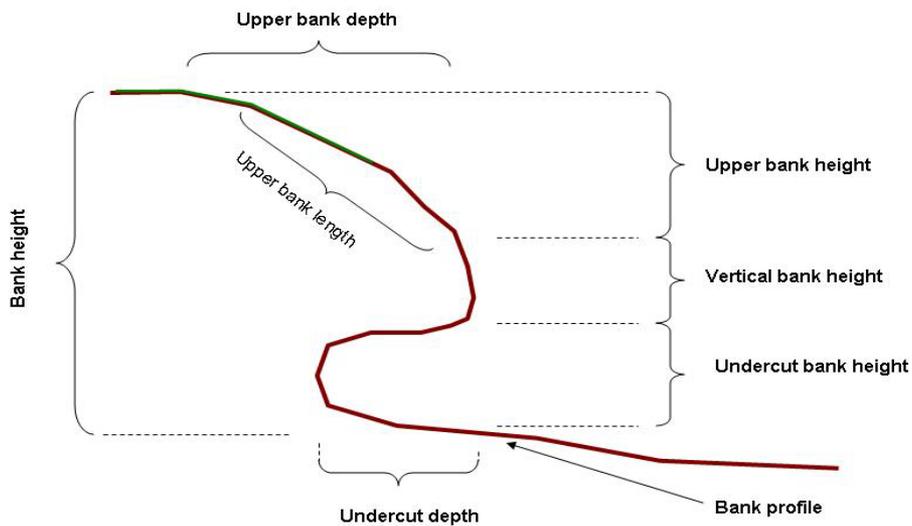
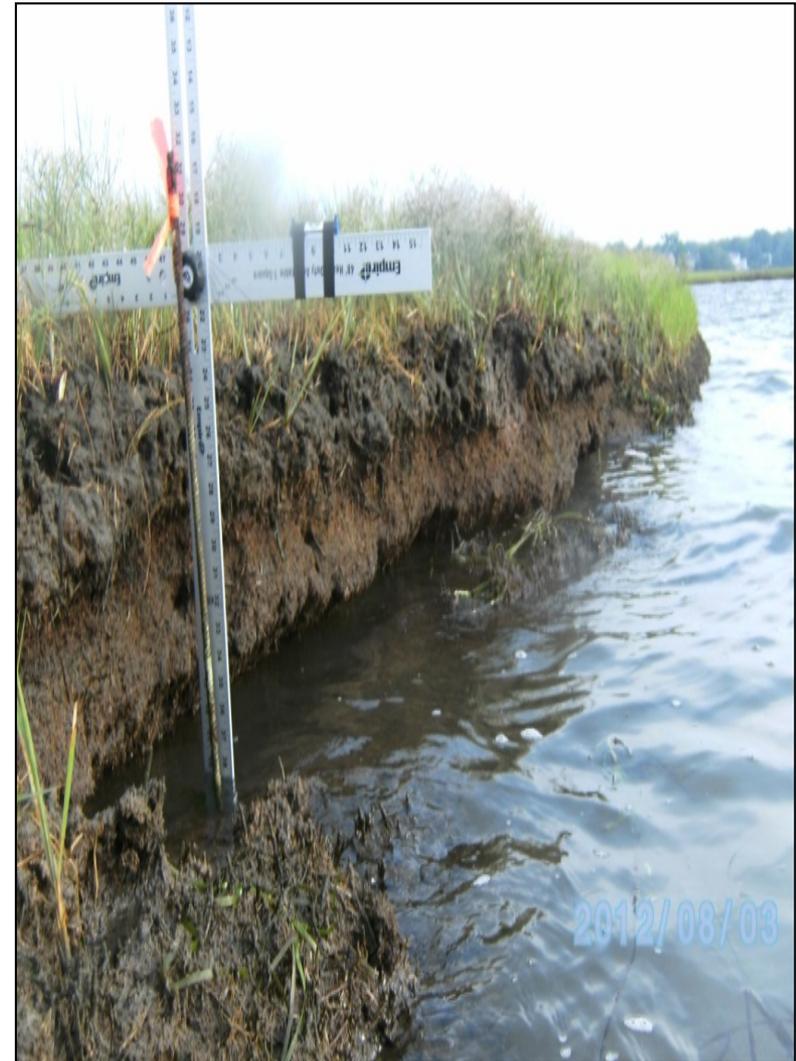
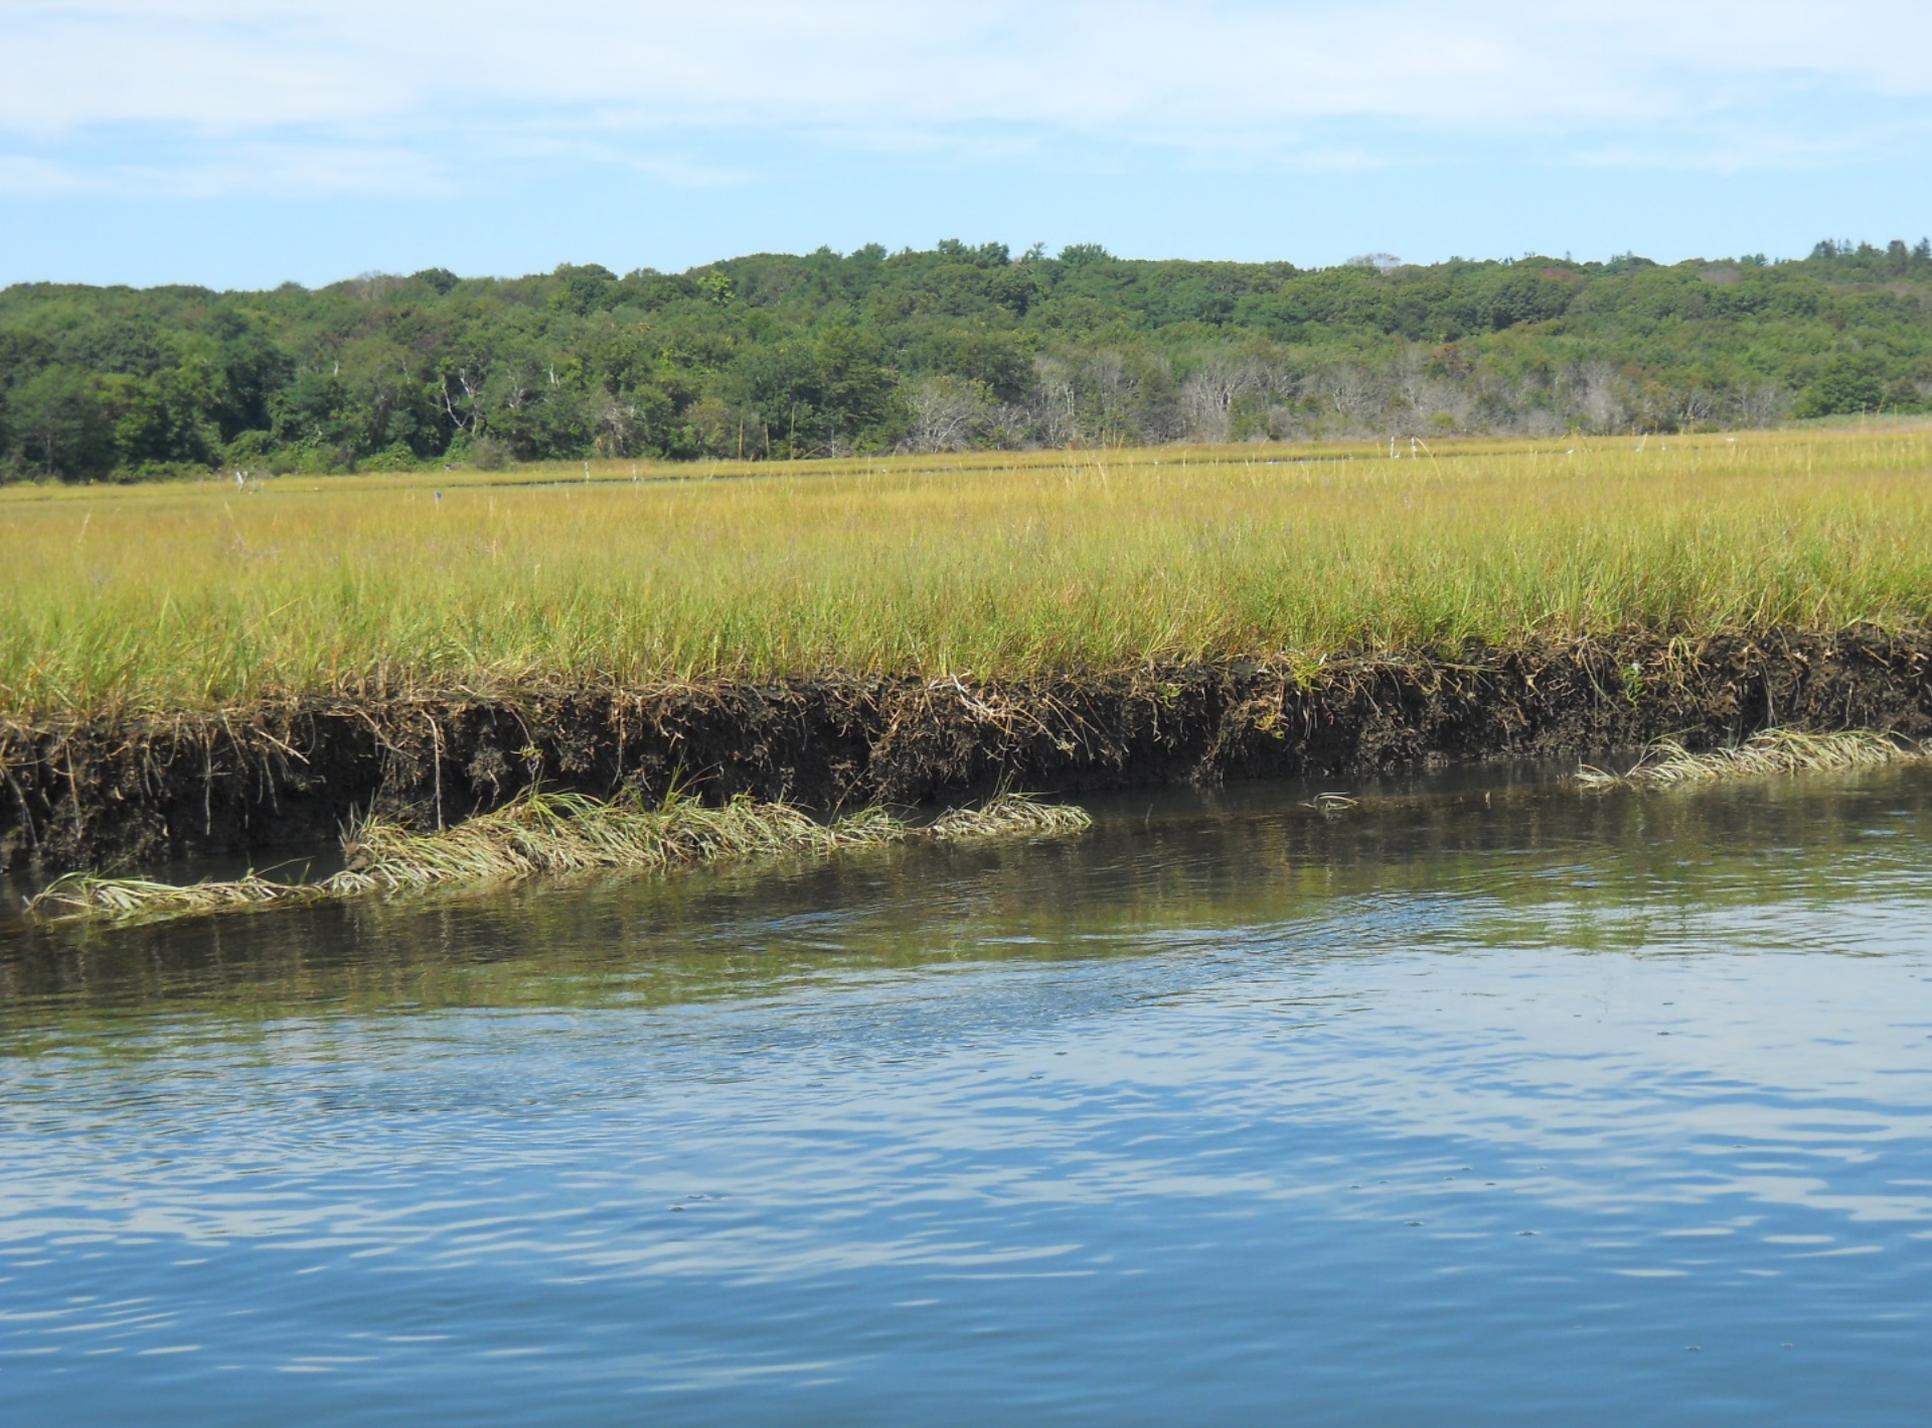
Initial observations - Shoreline Erosion

- Unstable Banks, Narrow River
 - Sections of marsh slump into river
 - Wind driven waves, boat wakes, crabs (green/fiddler)

Cross sectional view of typical saltmarsh riverbank, Lower Narrow River

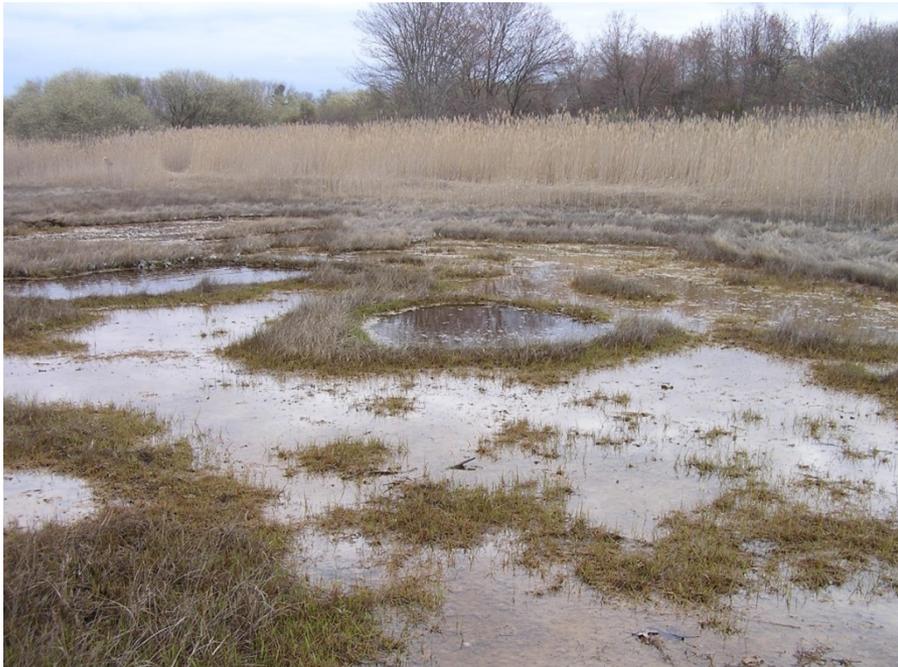
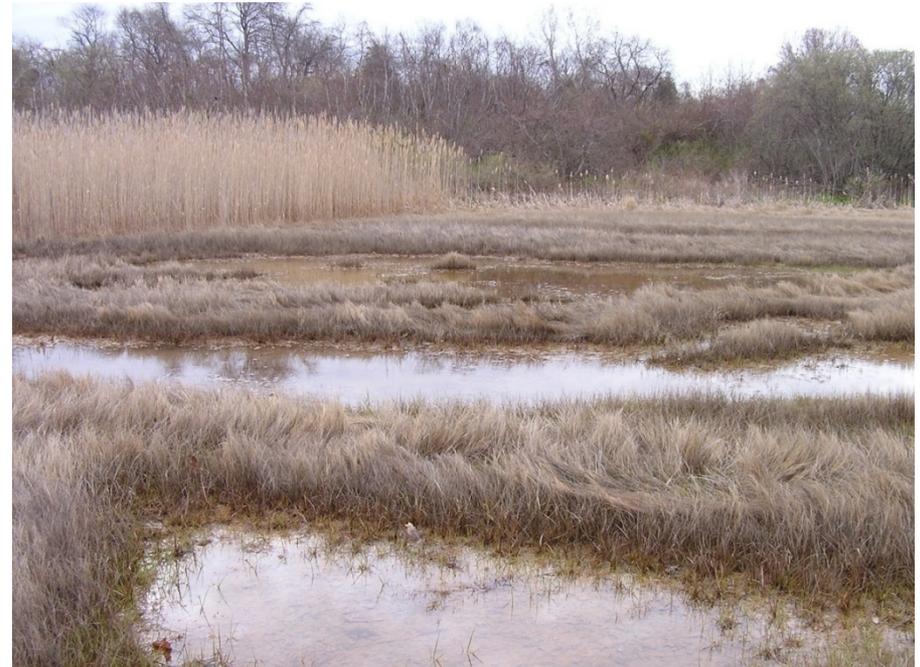
Initial observations – Impounded Water on Marsh

- Standing water on marsh
- Panne expansion (low plant density, stunted growth)
- Pool expansion

- Documented...
 - Rapid loss of *S. patens*, increase in *S. alterniflora* and transition of high marsh to low marsh
 - Dominant plant *S. alterniflora* (low, mixed marsh species)
 - Accretion not keeping up with SLR (low sediment in system, accretion due to biomass)
 - Dieback due to impounded water, loss of below ground biomass exacerbates pool & panne formation

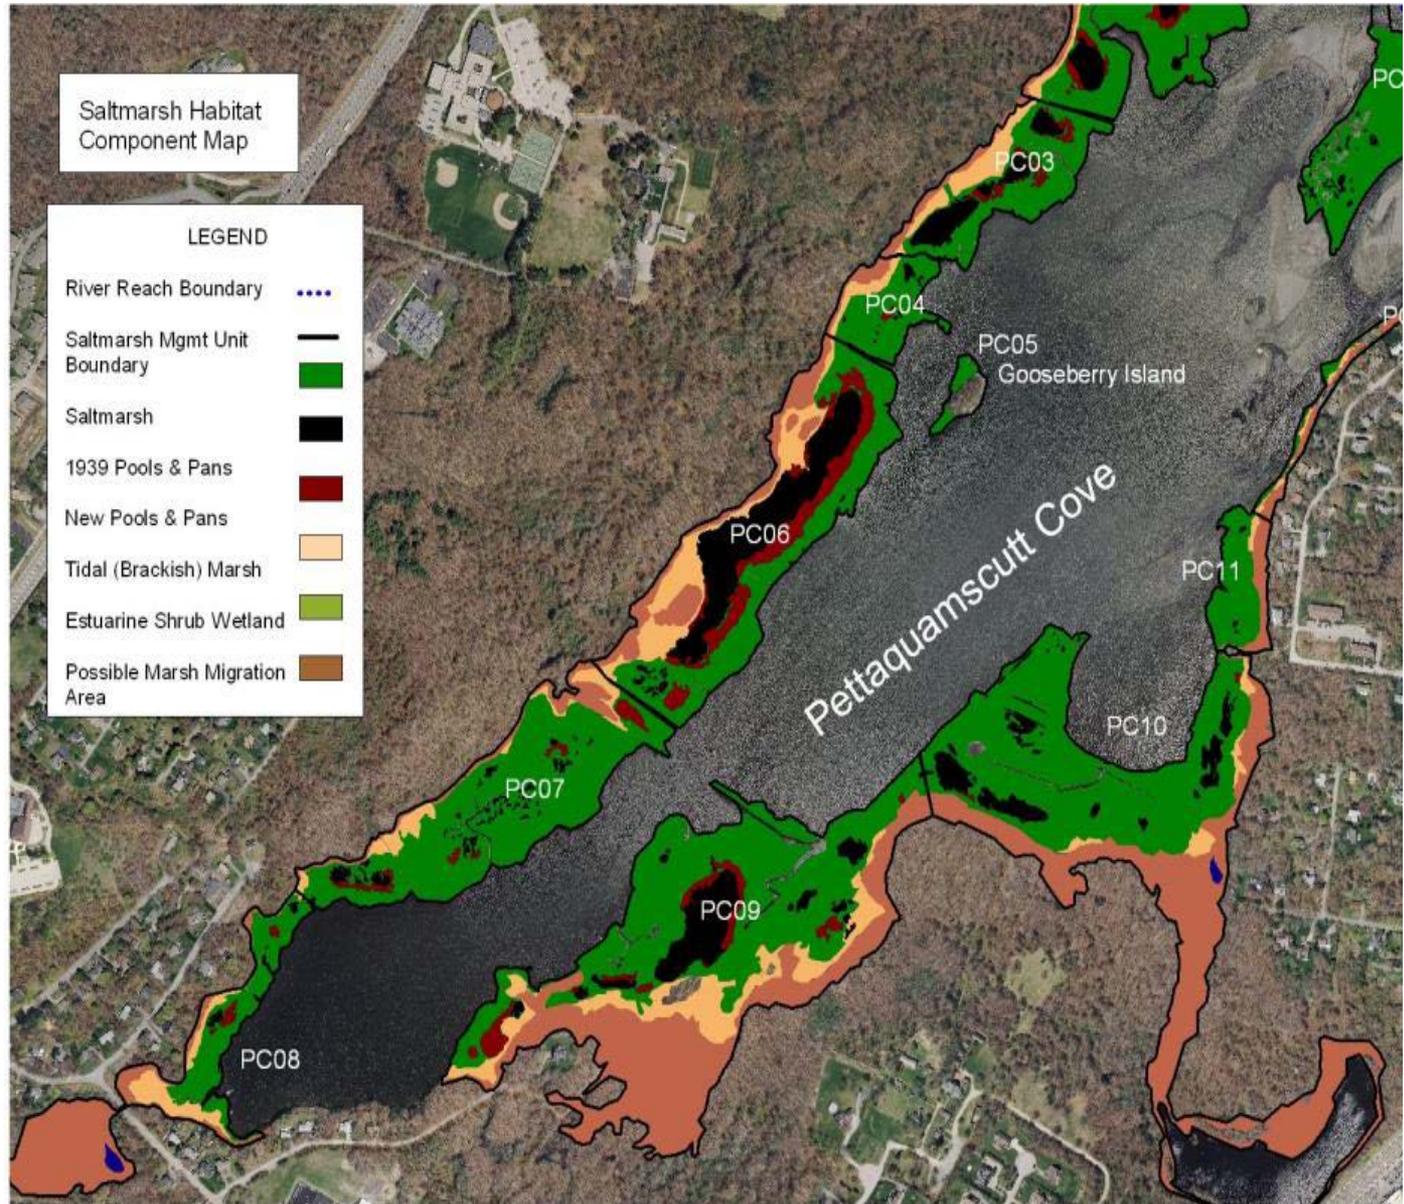
Pan and Pool Expansion

- Black = 1939 pool
- Rust = new pool

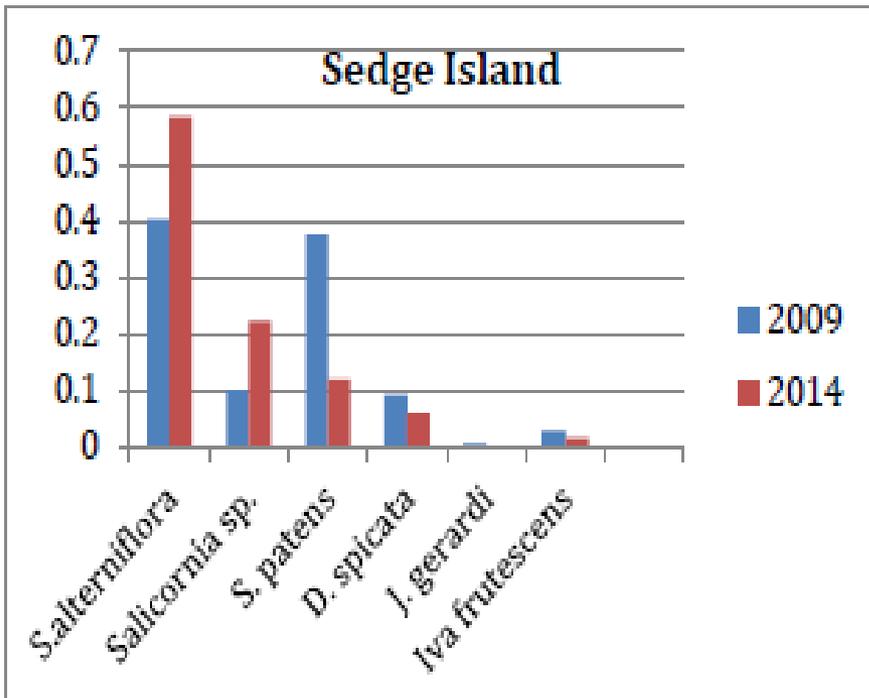
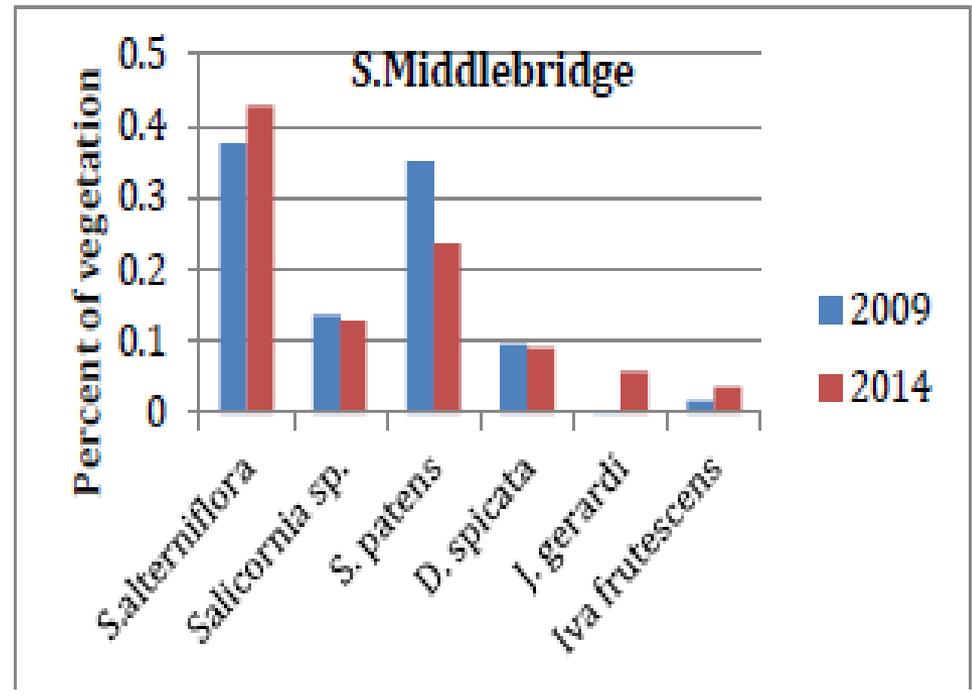
Initial observations - Vegetation Transition

- Saltmarsh Sparrow occupancy study (S. Paton, 2009)
- Loss of *Spartina patens* (high marsh species)
- Increase in *S. alterniflora* (low, mixed marsh species)

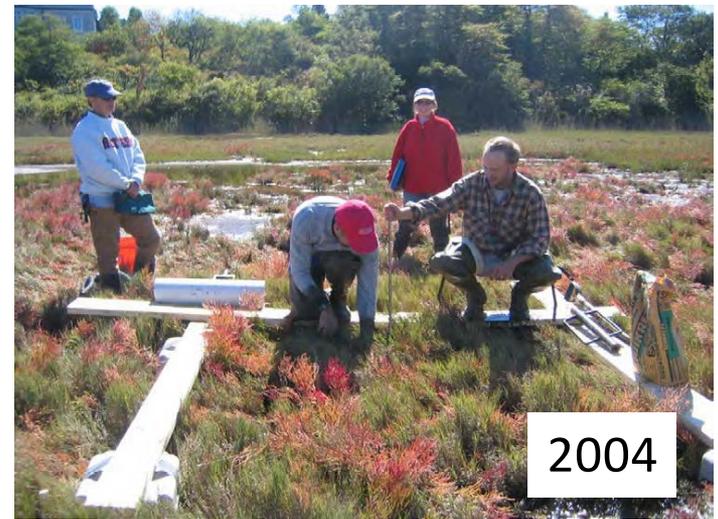
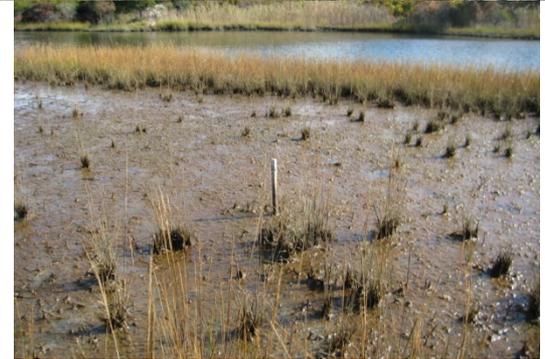
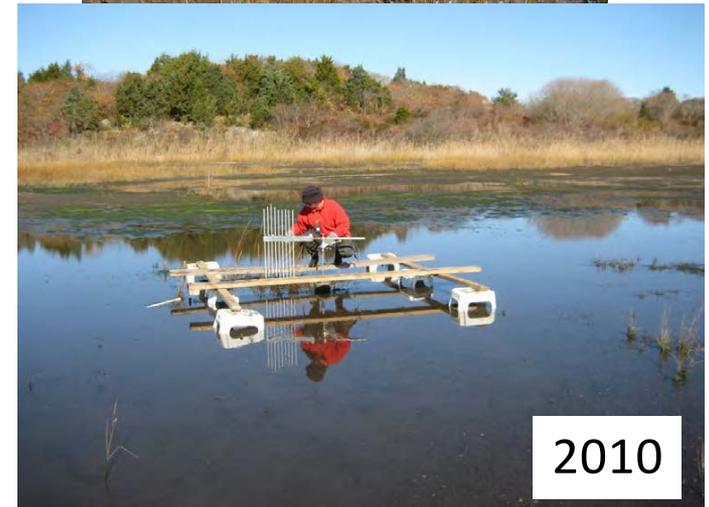
Initial observations – Sea Level Rise Faster than Accretion

- Raposa et al. 2016. Regional Environmental Change
 - Salt marsh elevation growth = 2 mm/year (Surface elevation tables (SETS) and horizon markers)
 - Sea level rise
 - 1930 – 2015 = 2.78 mm/year
 - 1999 – 2015 = 5.26 mm/year

Save The Bay –
Monitoring restoration
sites and documenting
rapid change in RI salt
marshes.

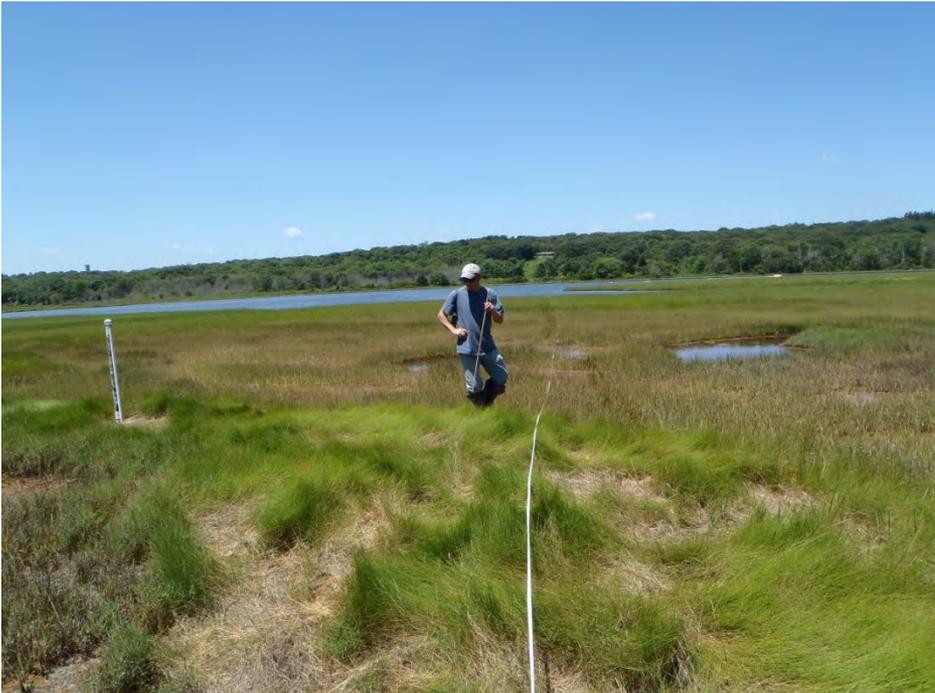
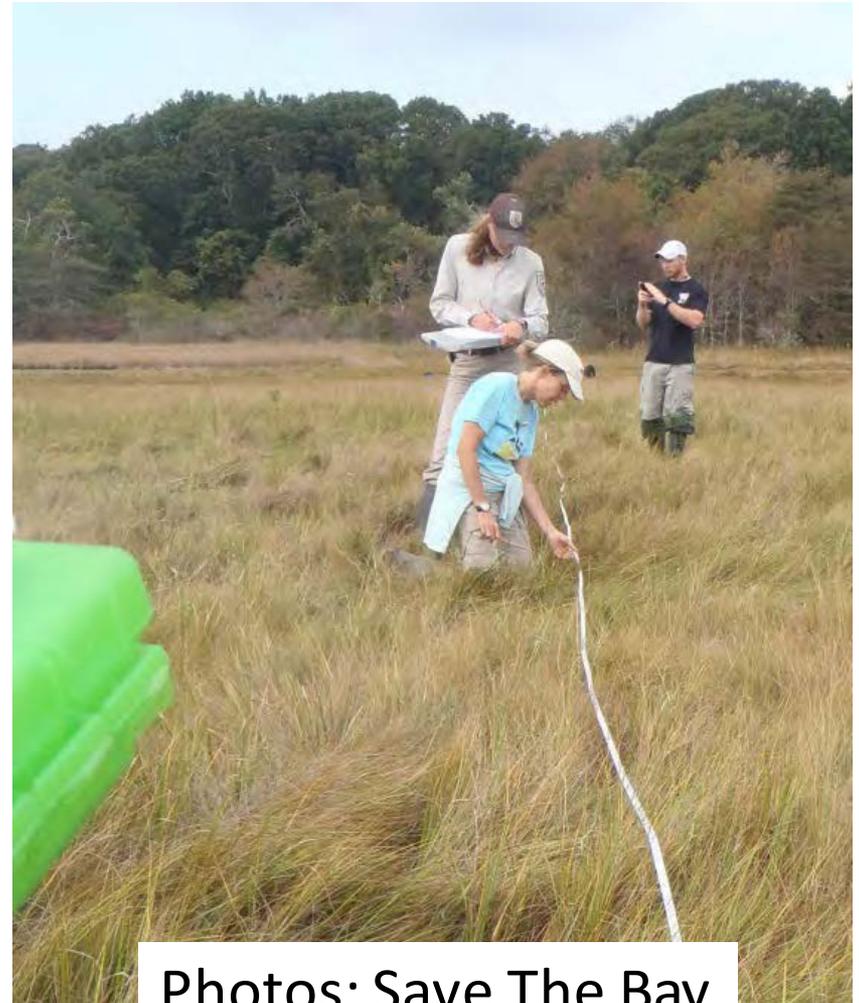
Rapid Assessment

- Belt transect
 - Plant species
 - Marsh zonation

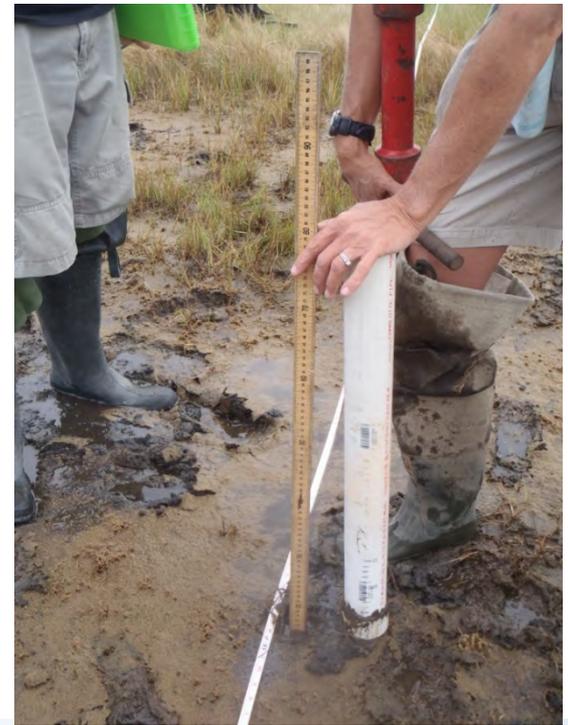
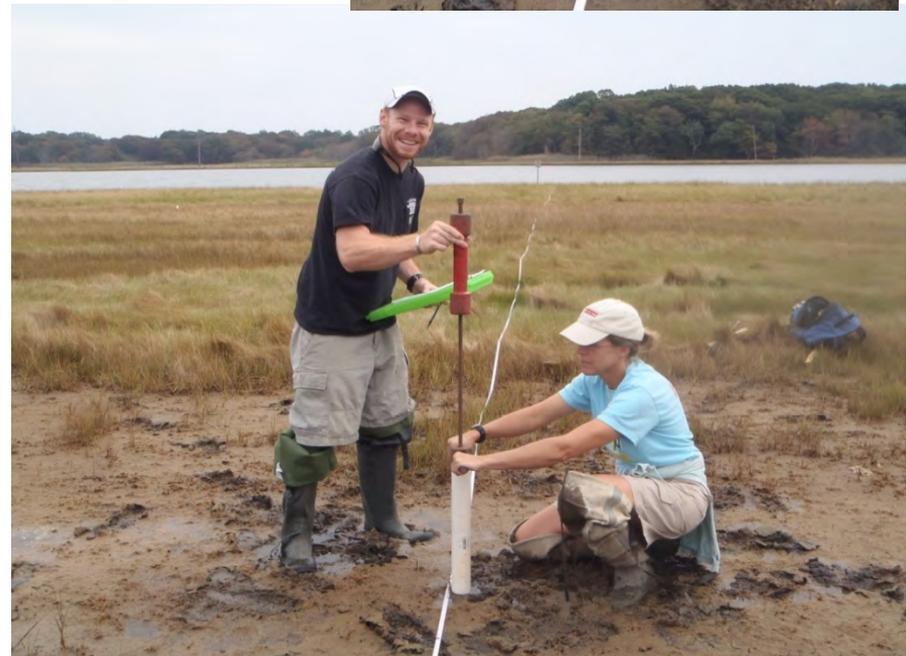
Rapid Assessment

- Soil Bearing Capacity (soil penetrometer)
 - High marsh had greatest capacity
 - Low marsh and pannes had lowest capacity
