Seal Beach National Wildlife Refuge Thin Layer Salt Marsh Sediment Augmentation Project Construction and Lessons Learned

Rick Nye - Refuge Biologist - Seal Beach NWR

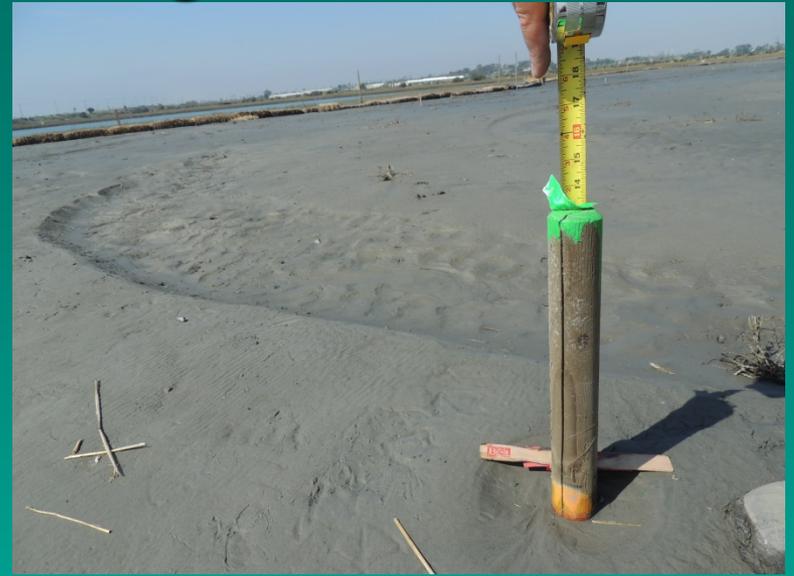
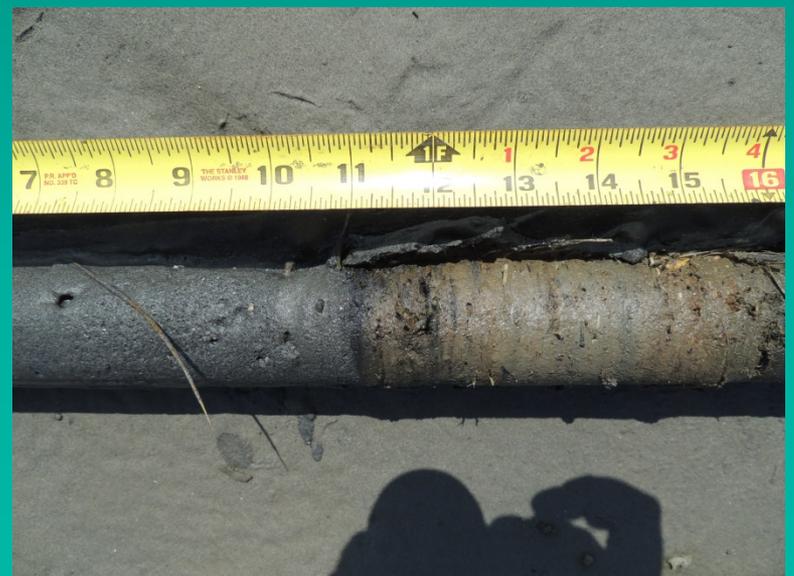
Estimating Depths During Construction

- New sediment compaction
 - 20% to 30% during 1st 72 hrs
- Variances in underlying marsh compaction
- Coring verification
 - Access
 - Labor intensive
- Bathtub/Lava effect
- Consistent pole installation standards
 - Research Team
 - Contractor
 - >500 grid + research poles

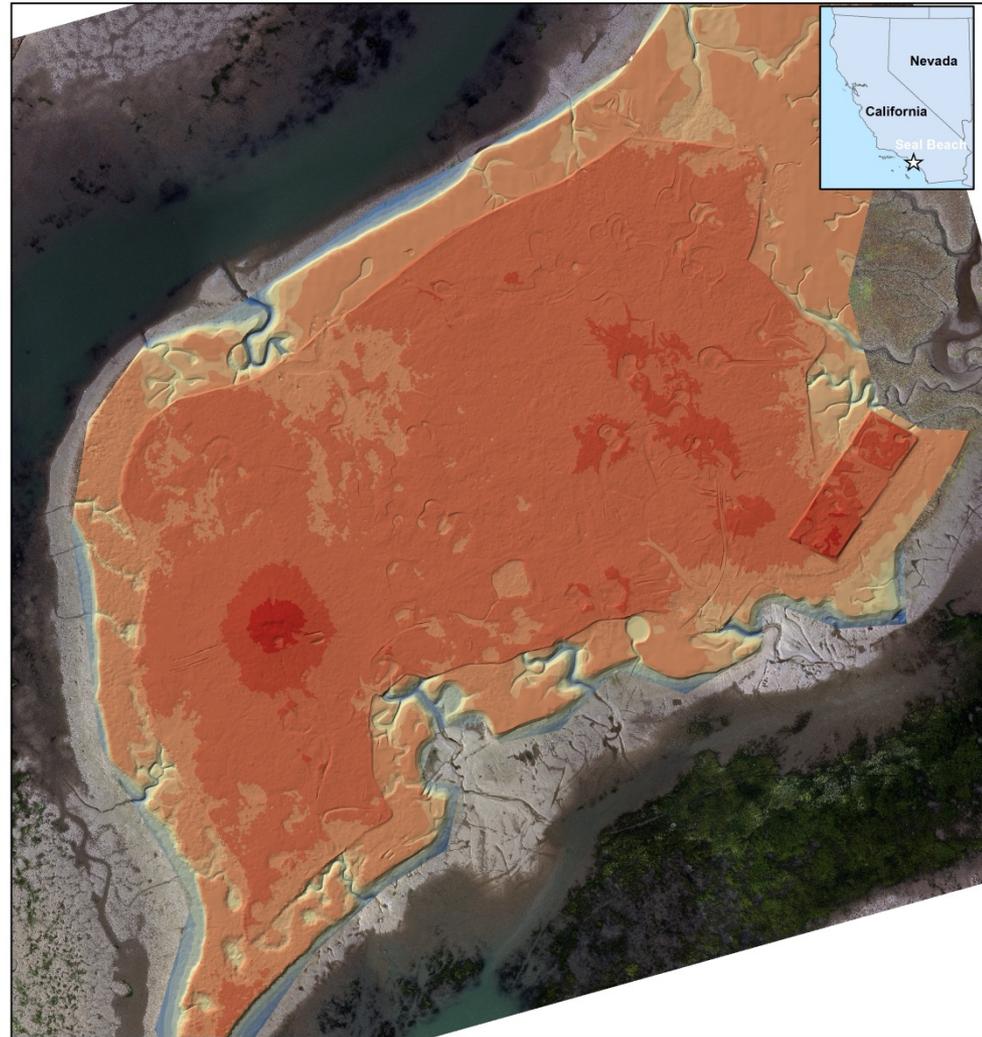
Salt Marsh Sediment Augmentation Project - April 2016

Photogrammetry survey –

- 0.1 - 0.05 ft accuracy

Calculated sediment depth –

- 9.6" on average
- 40% of poles were 10" + 1"
- 63% of poles were 10" + 2"
- Large depth variance across 40% of the site
